33-45 AVENUE ROAD & 136-148 YORKVILLE AVENUE HERITAGE IMPACT ASSESSMENT

ISSUED: MARCH 10, 2020

Appendix II: Condition Assessment (ERA)

Condition Assessment

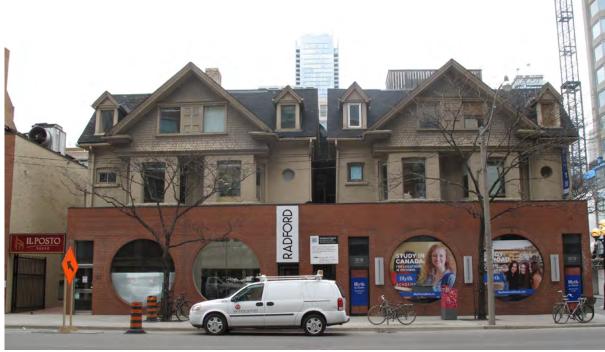
2. West Elevation of 33-41 Avenue Road - 2 1/2 semi-detached Historic building with connecting facade (ERA, 2016).

Overall, the west elevation of 33-41 Avenue Road is in poor condition. The masonry of the red brick facade exhibits chipping, general and localized areas of soiling. There is horizontal and step cracking in the masonry. Over the entire facade there are holes, caulking and remnant adhesive from old signage. To the north of the southwest corner, above the large circular window and door, are holes and exposed wiring from signage. The caulking along grade is peeling or completely deteriorated. On the southwest corner at grade, there is minor spalling of the brick. Overall the windows are in fair condition.

The visible portions of the historic buildings, this includes the second story and the attic, are in fair to poor condition. The paint on the bricks is stained, cracking and peeling. For each house, the trim is falling and the soffits are in poor condition: the paint is peeling and the wood is rotting, and the gutters are rusted and deteriorating. On the northern building, the soffit and gutter on the southwest corner of the gable is starting to separate from the roof.

The shingles on the gallow dormers on both houses are in fair condition. There is staining on the paint. Where the shingles curve outwards, the paint is peeling. On the northern building, the brick chimney is spalling and majority of the paint has peeled off. All of the windows appear to have been replaced. The dormers are in poor condition, the paint is peeling and the lower portion of the wooden window trim is rotting. On the southern building, the shingles are in good condition. The shingles on the northern building are in poor condition and are curling.

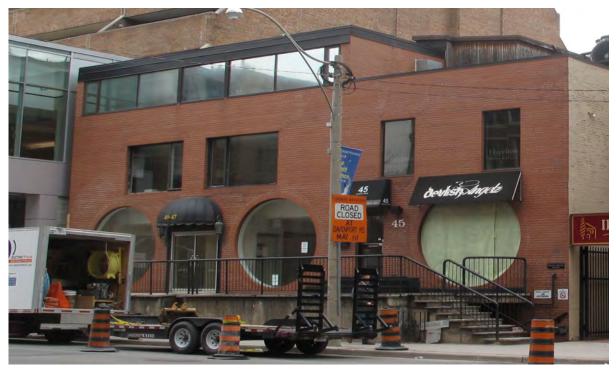
9. West Elevation of 45-49 Avenue Road - two story brick building (ERA, 2016).

Overall, the west elevation of this building is in fair to poor condition. On the south elevation of the porch, there are stairs down to a partly below grade entrance. In this area, everything is in poor condition. Any metal within this area is rusted, the paint on the wooden door is peeling, there is effloressence on the brickwork and the stone veneer steps are chipped.

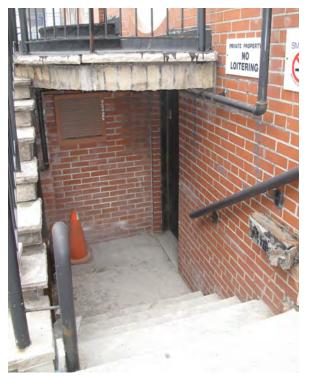
The north elevation of the porch was exposed in 2016 showing the layers of brick and concrete construction with a stone veneer, and is now covered by metal panelling. The porch and associated stairs are in poor condition. Chunks of concrete have fallen off the porch in various locations, the stone veneer is chipped and some of the stones are dislodged, there are a few areas with effloressence, general soiling, staining, organic growth, some graffiti and spots of rust.

10. Stairs and landing for below grade entrances under 45 Avenue Road porch (ERA, 2016).

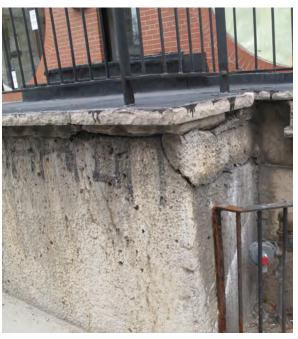
On the surface of the landing, the area of the porch associated with 45 Avenue Road is covered with tar sheets, which are in good condition. The tar treatment has dripped over the edges of the landing. The veneer on the north part of the landing consists of a combination of stone and concrete panels, both are in fair condition.

12. Partial view of porch in front of 45 Avenue Road, detail of tar sheets and deteriorating concrete (ERA, 2016).

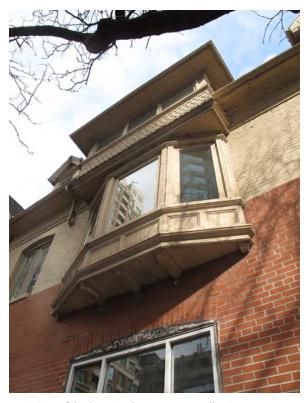
The second level and attic are in the same condition as the west elevation. In general, the paint is peeling off the masonry and wood. The wood of the bay window and soffits are rotting, and the decorative shingles are in fair condition with deteriorated paint finish.

14. View of the bay window, remnant adhesive present on the window below (ERA, 2016).

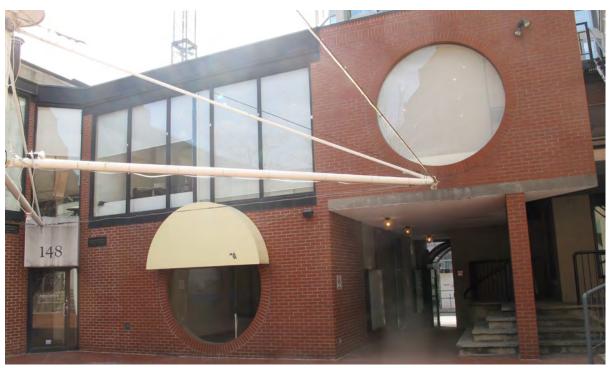
17. View of south courtyard wall (ERA, 2016).

Overall, the south elevation is in fair condition. There is some cracking in the masonry, chipping of the bricks and minor staining at grade. The stucco on the underside of concrete slab over the entrance walkway is falling off and the there is horizontal cracking in the concrete. The metal frame around the window is rusted and lifting, a shim on the east side has popped out and there is exposed wiring running from the awning of the southeast corner to the window frame.

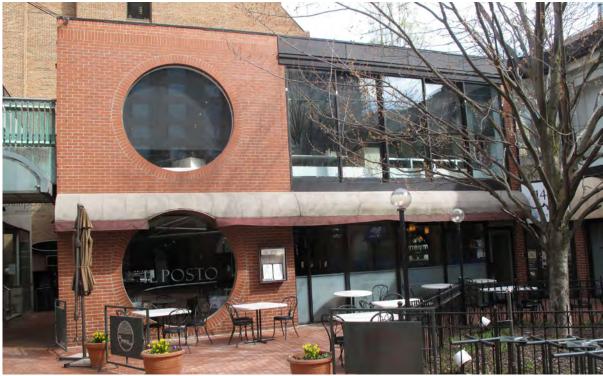
22. North courtyard wall (ERA, 2016).

Overall, the north elevation is in fair condition. General wear and weathering of the masonry, minor chipping of the corner of the bricks at the northwest corner are visible. There is weather soiling on the canopy.

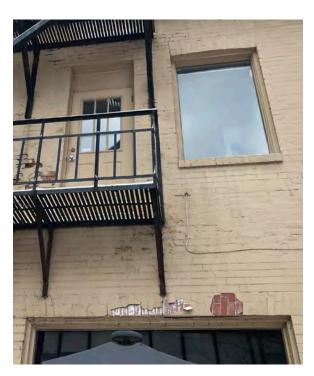
33. Detail paint condition on wall (ERA, 2020).
