33-45 AVENUE ROAD & 136-148 YORKVILLE AVENUE HERITAGE IMPACT ASSESSMENT

ISSUED: MARCH 10, 2020

Appendix II: Condition Assessment (ERA)

Condition Assessment

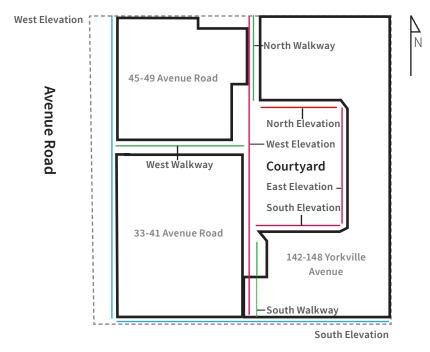
1. Subject property: Street facing elevations are indicated by the blue lines, walkways are indicated by the green lines and the court yard elevations are indicated by the red lines, approximate subject property boundary indicated by dashed grey line (ERA, 2016;2020).

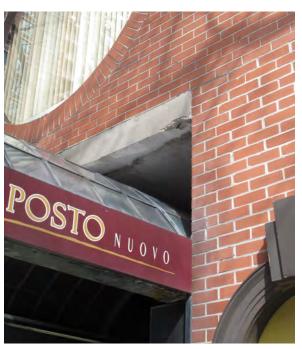
16. Detail of entrance to the south walkway (ERA, 2016).
